Impact Assessment Report- Haritha Samrudhi Project- Phase 1 (Kerala)

United Breweries Limited (UBL)

January 2024

6.1. Annexure- 1: Detailed Findings of the structures visited

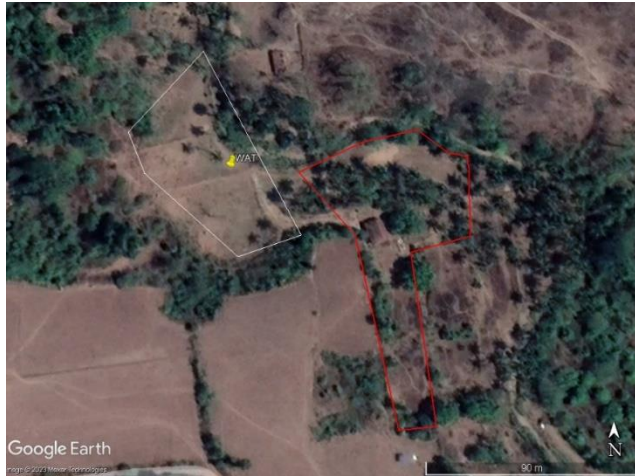
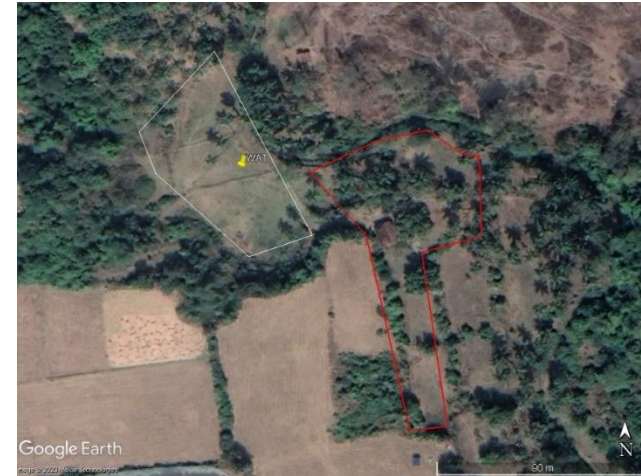
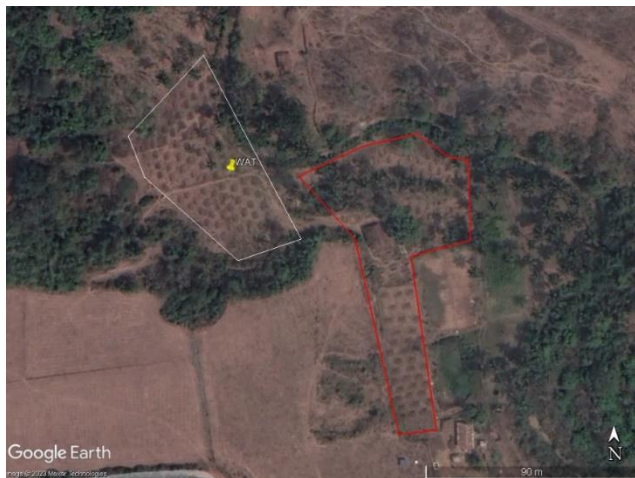
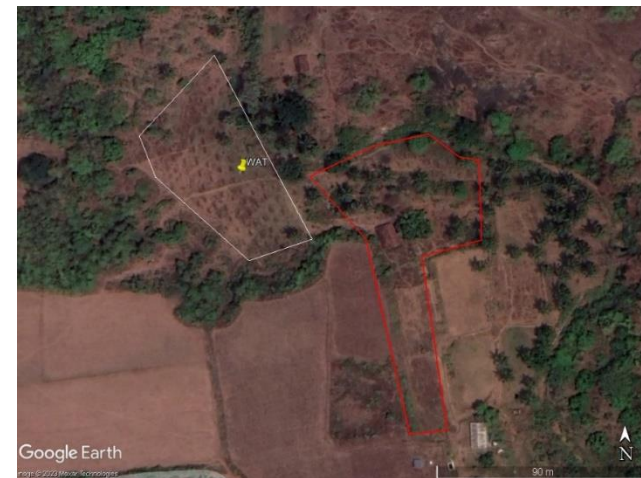
Table 19 Changes to a field provided with WATs, 2019 – 2022 (Source: Images retrieved from Google Earth Pro on 22 Oct 2023)

March, 2019

January, 2020

March, 2021

March, 2022

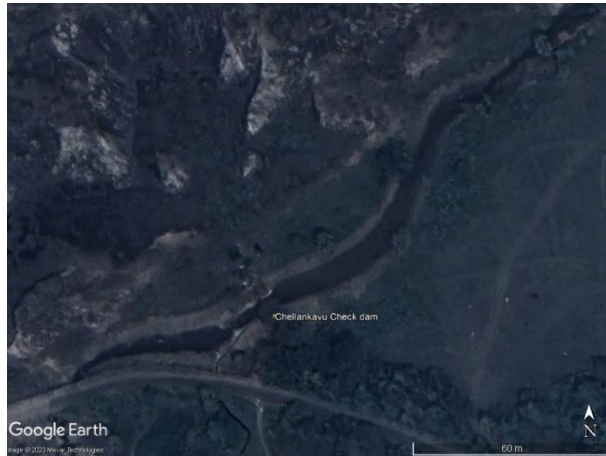
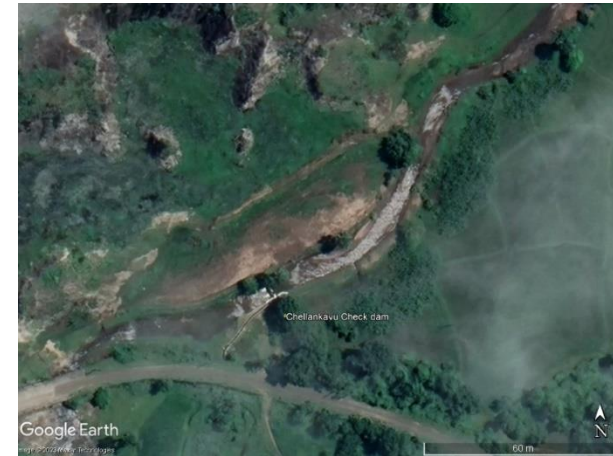
Table 23 Changes in condition of the stream after construction of Chellankavu check dam, 2019 – 2022 (Source: Images retrieved from Google Earth Pro on 22 Oct 2023)

December, 2021

August, 2022

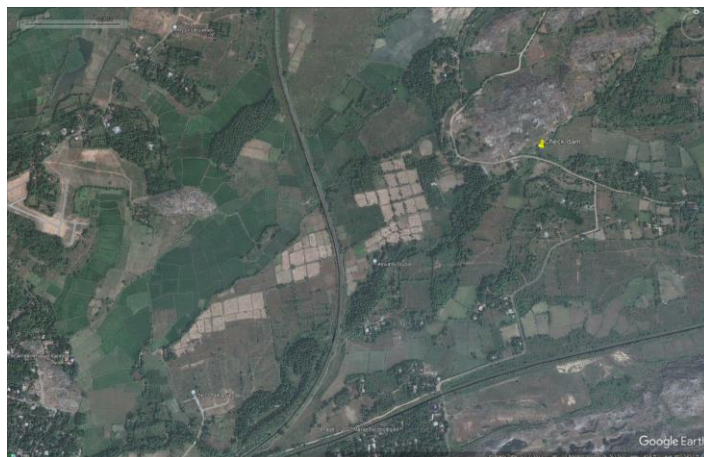
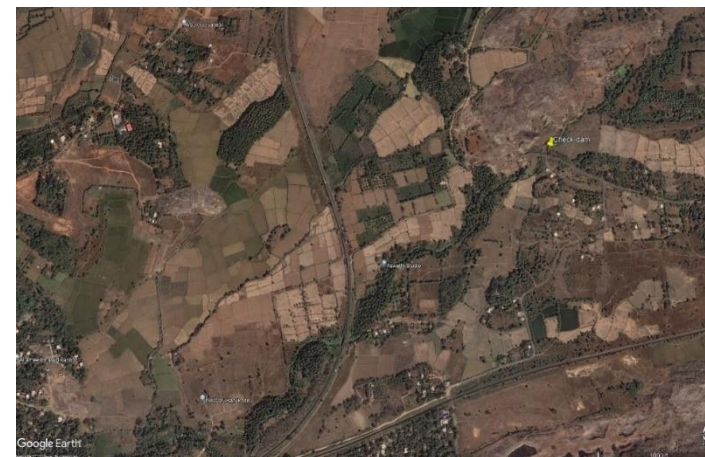
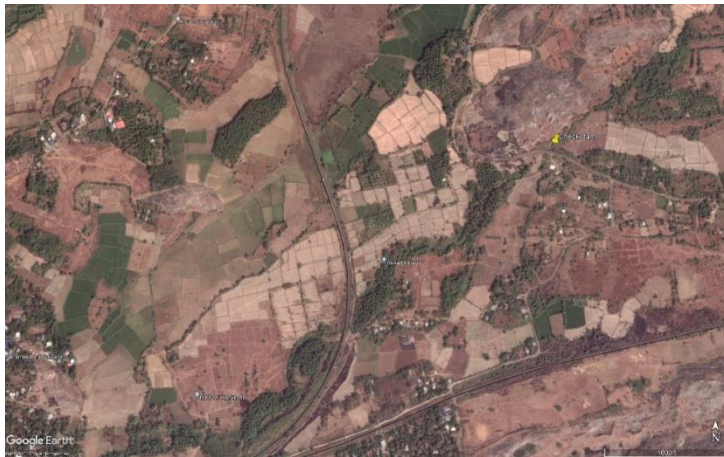
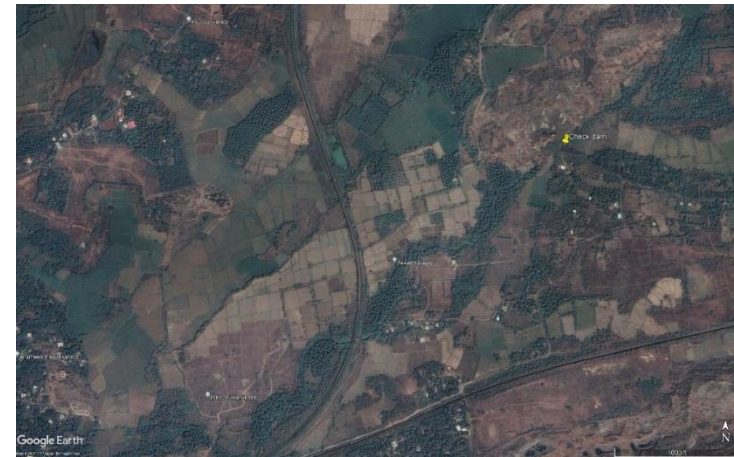
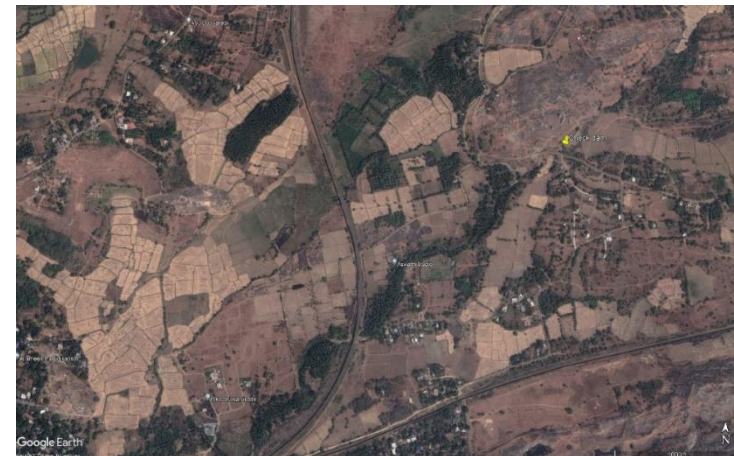
Farmers' claims regarding increased overall productivity through the cultivation of a second crop are evaluated using historical satellite imagery. Analysis of satellite pictures taken before and after the intervention during the Rabi farming season, spanning from November to February, does not indicate any significant changes in the cropping patterns. However, availability of historical satellite imagery is limited.

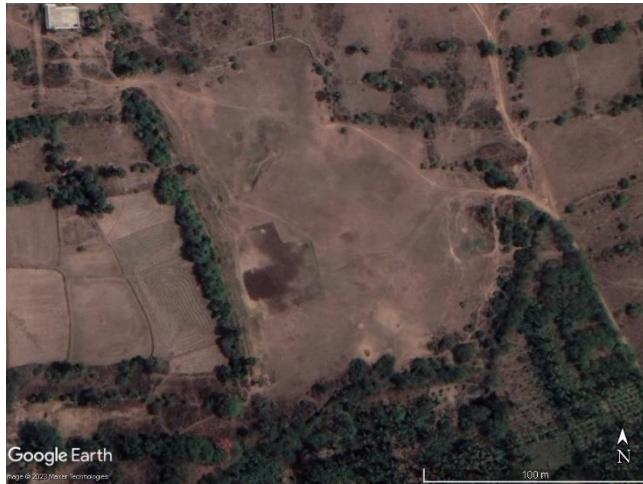
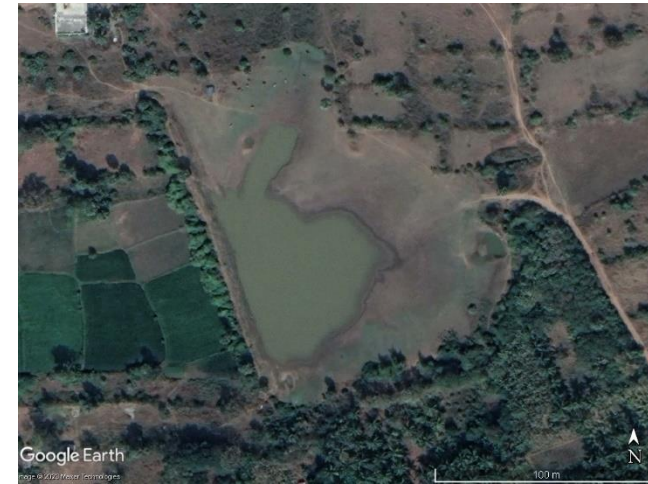
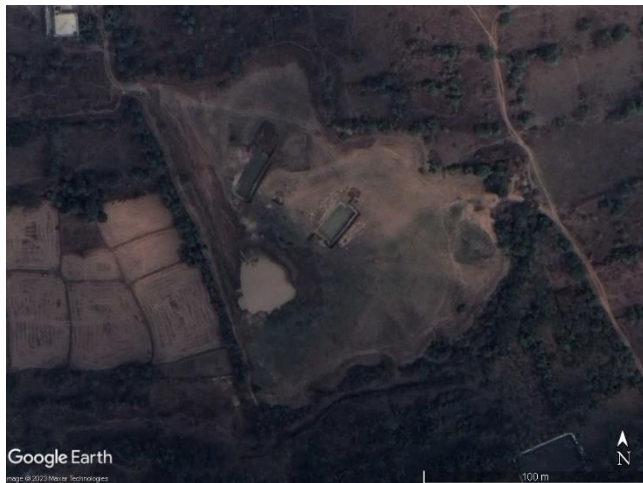
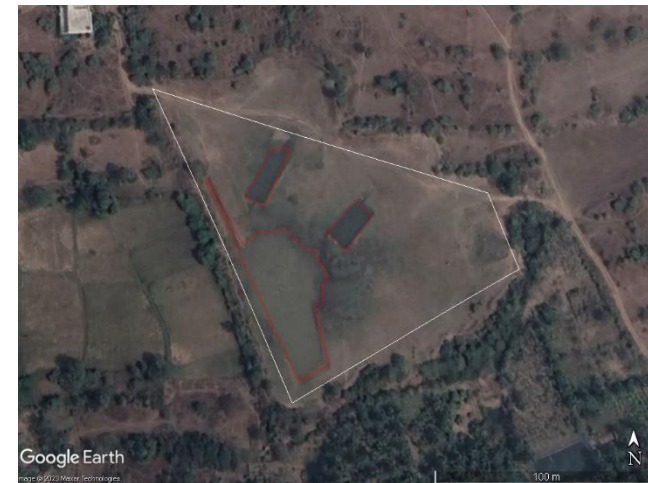
Table 25 Changes in condition of Bodichettieri big pond from 2019 – 2022 (Source: Images retrieved from Google Earth Pro on 22 Oct 2023)

April, 2019

January, 2020

March, 2021

February, 2022

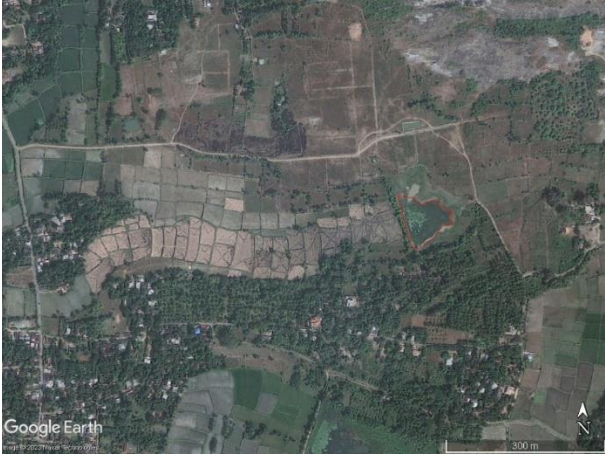
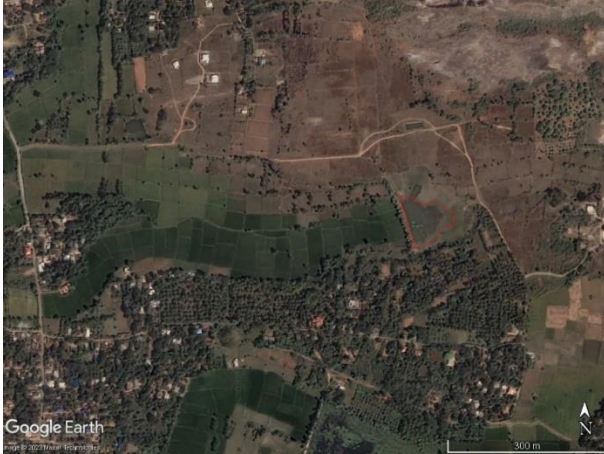
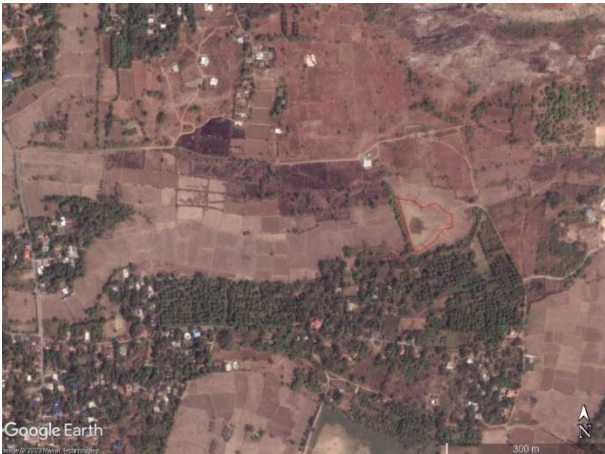
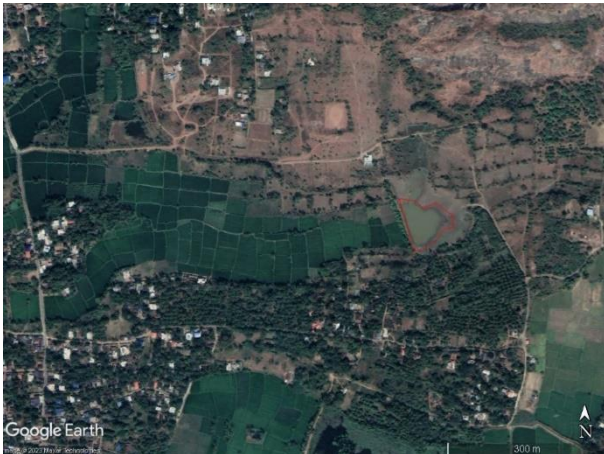
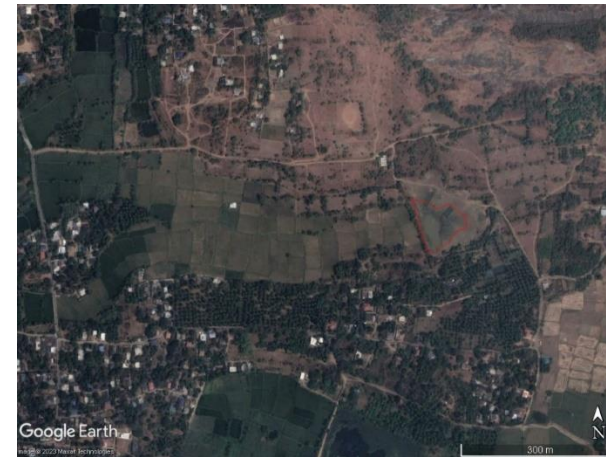
Historical satellite images for assessment of Bodichettieri big pond		
<p>Rabi (Nov-Feb)</p>	<p>Dec 2012</p>

Farmers' claims regarding increased overall productivity through the cultivation of a second crop were evaluated using historical satellite imagery. Analysis of satellite pictures taken before and after the intervention during the Rabi farming season, spanning from November to February, does not indicate any significant changes in the cropping patterns during the Rabi season. However, availability of historical satellite imagery is limited.
