Impact Assessment Study- UBL

Participatory water conservation through rejuvenation of water bodies in Thiruvallur district, Tamil Nadu - United Breweries Limited

March 2023

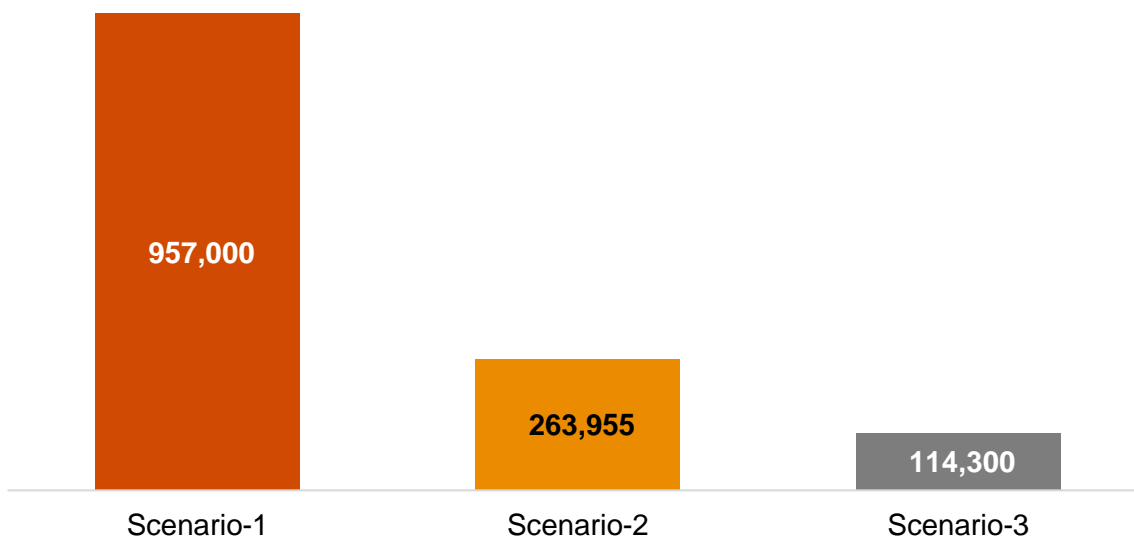
Volumetric water benefits in each scenario for FY21-22 (KL)

Accordingly, the storage volumes and potential Volumetric Water Benefit created by the intervention as compared to the total water withdrawals from the Empee and Chennai plants are presented in Table 6 below. The detailed calculations for the estimates of Volumetric Water Benefit can be found in Annexure 3.

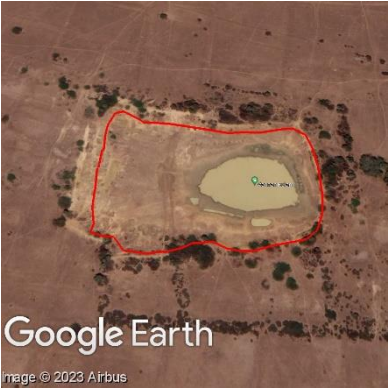
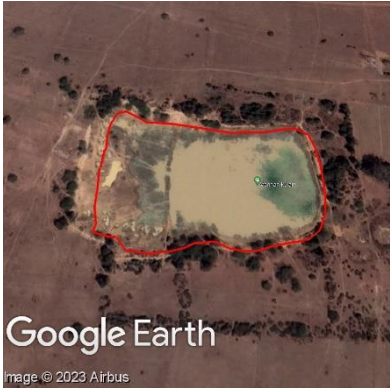
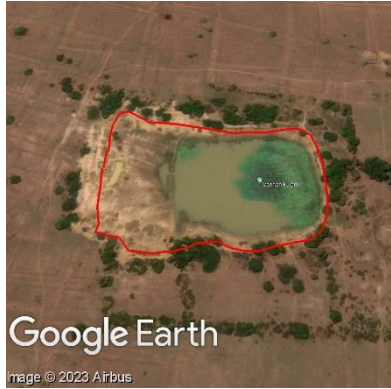
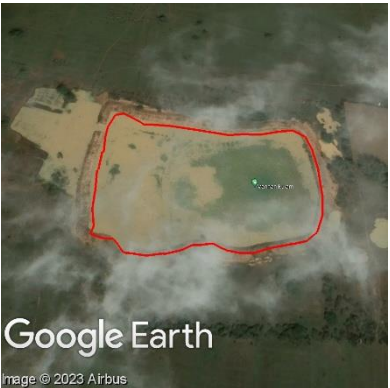
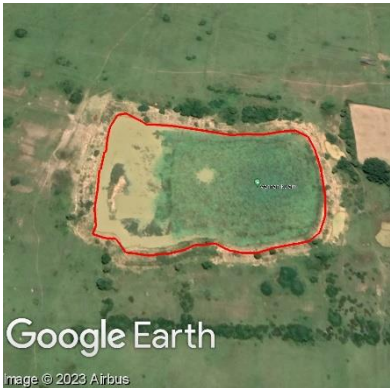
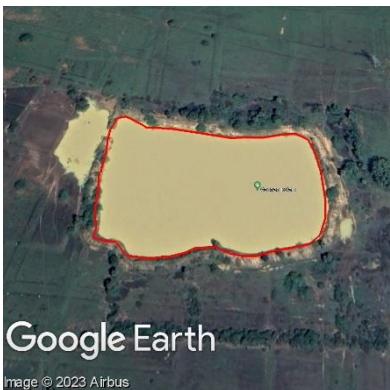
5.4.3. Vannan Kulam, Aranvoyal

<p>Google Earth image © 2023 Airbus</p>
<p>Vannan Kulam : March 2019</p>	<p>Vannan Kulam : March 2020</p>	<p>Vannan Kulam : May 2020</p>

<p>Google Earth image © 2023 Airbus</p>	  <p>Google Earth image © 2023 Airbus</p>
<p>Vannan Kulam : Feb 2021</p>	<p>Vannan Kulam : August 2021</p>	<p>Vannan Kulam : March 2022</p>
  <p>Google Earth image © 2023 Airbus</p>

<p>Google Earth image © 2023 Airbus</p>
<p>Vannan Kulam : October 2022</p>	<p>Vannan Kulam: Jan 2023</p>	<p>Vannan Kulam: Jan 2023 zoomed out</p>

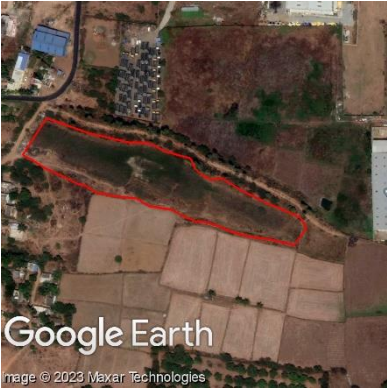
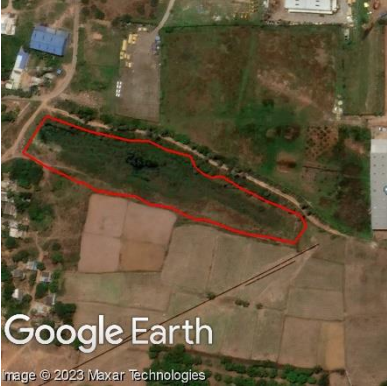
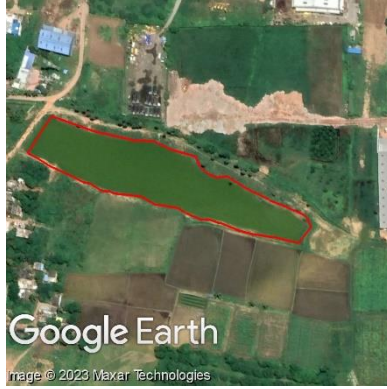
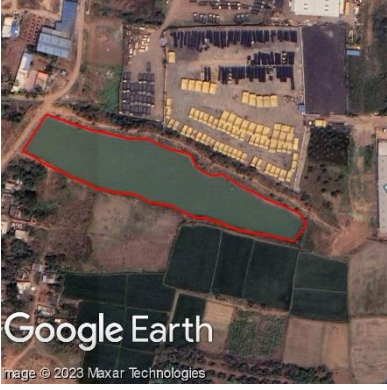
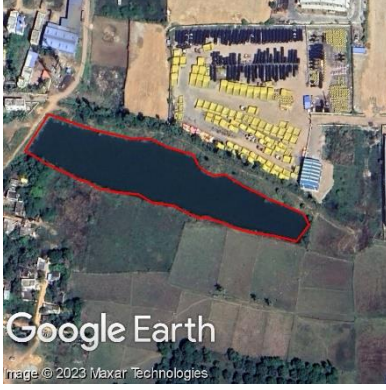
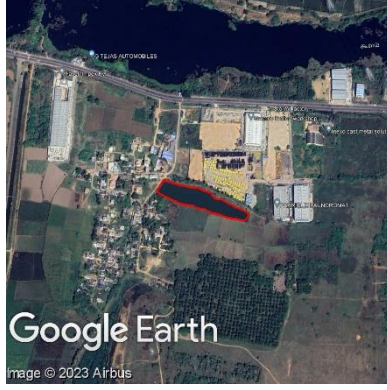
5.4.4. Thangal Eri -1, Murukancherry

<p>Google Earth image © 2023 Maxar Technologies</p>	  <p>Google Earth image © 2023 Maxar Technologies</p>
<p>Thangal Eri 1 : March 2019</p>	<p>Thangal Eri 1: Feb 2020</p>	<p>Thangal Eri 1: March 2020</p>

<p>Google Earth image © 2023 Maxar Technologies</p>
<p>Thangal Eri 1 : May 2020</p>	<p>Thangal Eri 1 : Feb 2021</p>	<p>Thangal Eri 1 : August 2021</p>

<p>Google Earth image © 2023 Airbus</p>
<p>Thangal Eri 1 : March 2022</p>	<p>Thangal Eri 1 : Jan 2023</p>	<p>Thangal Eri 1 : Jan 2023 zoomed out</p>

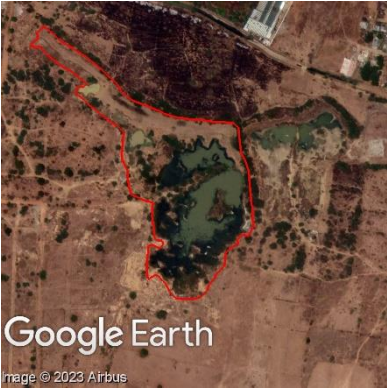
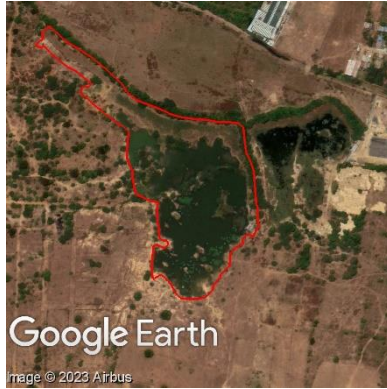
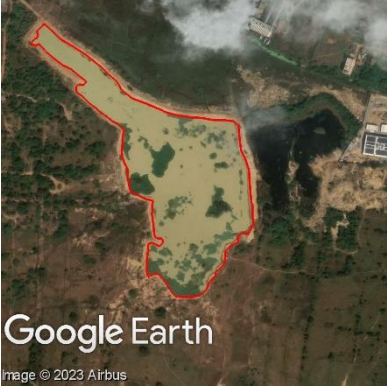
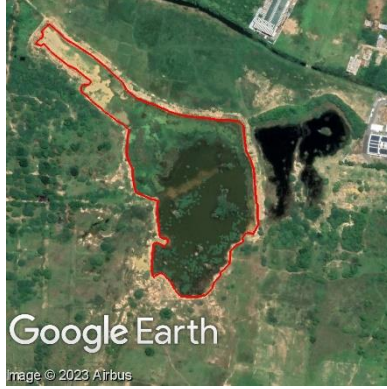
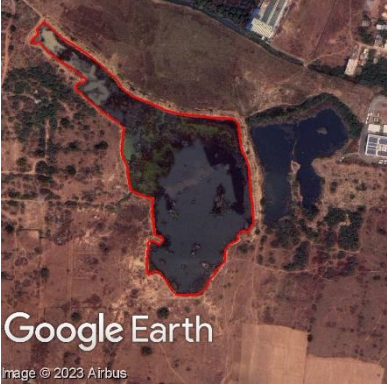
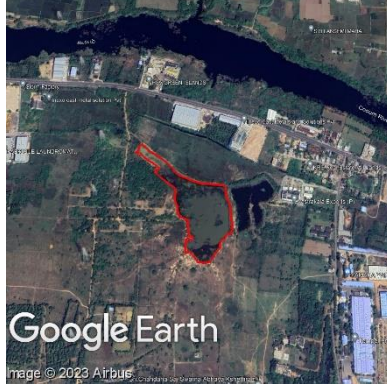
5.4.5. Thangal Eri -2, Murukancherry

<p>Google Earth image © 2023 Airbus</p>
<p>Thangal Eri 2 : March 2019</p>	<p>Thangal Eri 2: March 2020</p>	<p>Thangal Eri 2 : May 2020</p>

<p>Google Earth image © 2023 Airbus</p>
<p>Thangal Eri 2 : Feb 2021</p>	<p>Thangal Eri 2 : July 2021</p>	<p>Thangal Eri 2 : August 2021</p>

<p>Google Earth image © 2023 Airbus</p>
<p>Thangal Eri 2 : March 2022</p>	<p>Thangal Eri 2 : Jan 2023</p>	<p>Thangal Eri 2 : Jan 2023 zoomed out</p>

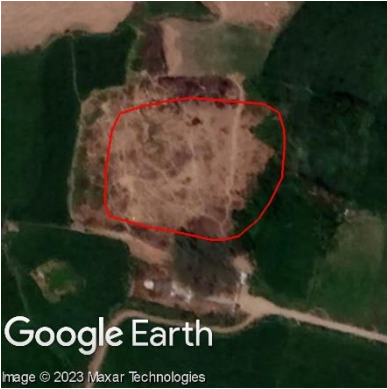
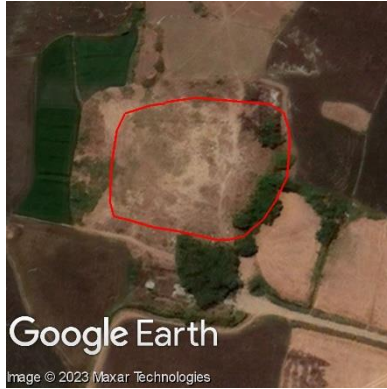
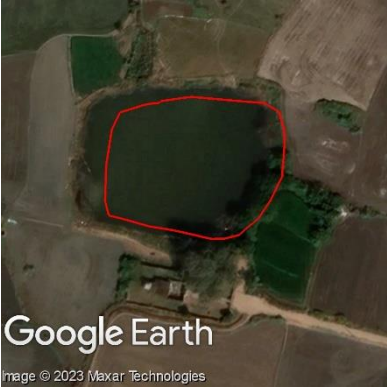
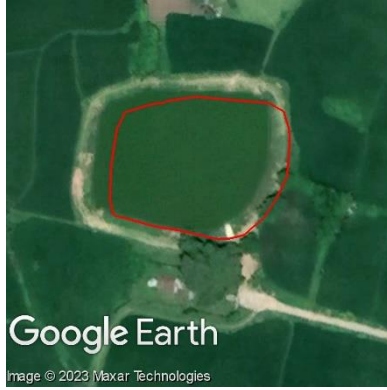
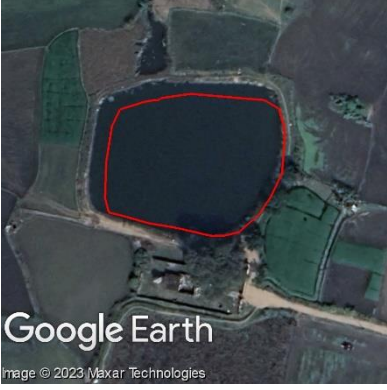
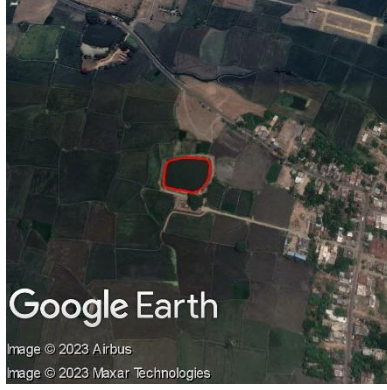
5.4.7. Pillaiyarkovilkulam, Kuthumbakkam

<p>Google Earth Image © 2023 Maxar Technologies</p>
<p>Pillaiyarkulamkovil :March 2019</p>	<p>Pillaiyarkulamkovil : March 2020</p>	<p>Pillaiyarkulamkovil : May 2020</p>

<p>Google Earth Image © 2023 Maxar Technologies</p>
<p>Pillaiyarkulamkovil: Feb 2021</p>	<p>Pillaiyarkulamkovil: July 2021</p>	<p>Pillaiyarkulamkovil: August 2021</p>

<p>Google Earth Image © 2023 Airbus Image © 2023 Maxar Technologies</p>
<p>Pillaiyarkulamkovil: February 2022</p>	<p>Pillaiyarkulamkovil: June 2022</p>	<p>Pillaiyarkulamkovil: June 2022 zoomed out</p>

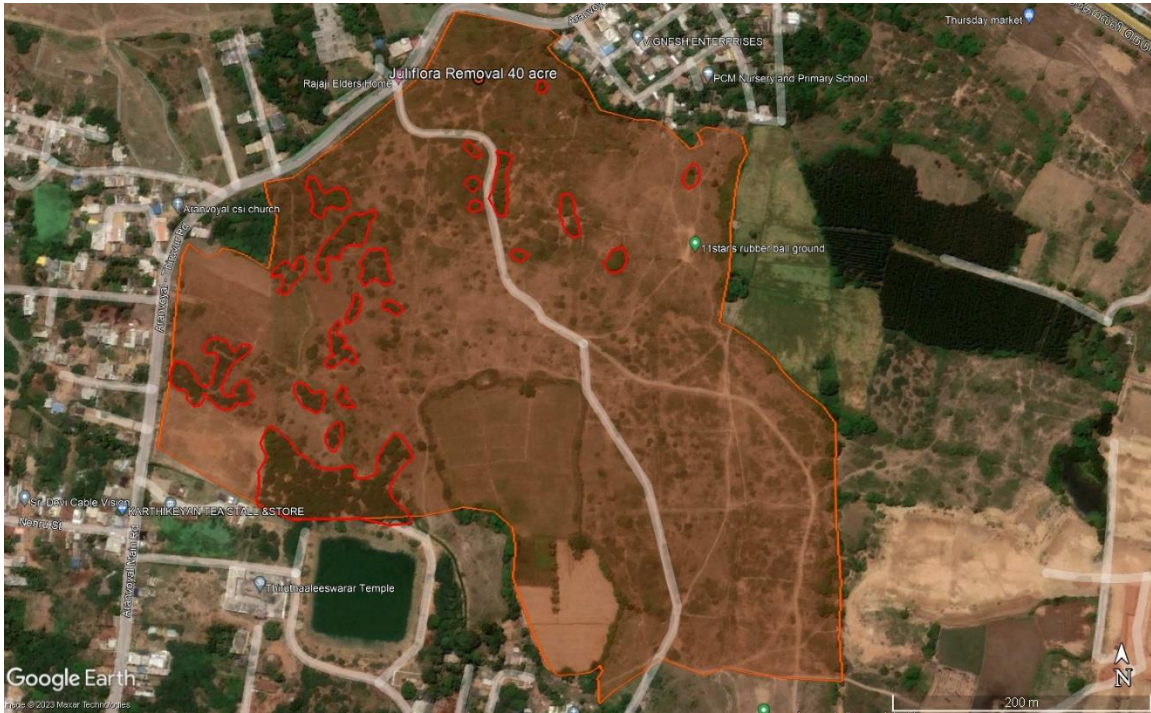
5.5.1. Major cluster of Juliflora within Land Parcel 1 and 2 before intervention

Further review of the satellite imagery for the two sites indicated that these sites were not entirely covered by vegetation (possibly *Prosopis juliflora*) historically. However, sparse clusters of the vegetation were observed within these sites. Hence, for the purpose of this assessment the major cluster of such vegetative **growth prior to the intervention (i.e., May 2020)** were marked and measured using GIS tool - Google earth (Annexure 5). All such vegetative growth within the delineated clusters were assumed to be *Prosopis Juliflora* due to limitation in differentiating between differences of species from available satellite imagery. Accordingly, **~3.21 acres of land was observed to be covered by vegetation within claimed land area¹² of 42.7 acre** of Land Parcel 1, and **~4.21 acres of land was observed to be covered by vegetation within claimed area of 21.4 acre** of Land parcel 2. As such, **effective area with respect to land reclamation from *Prosopis juliflora* would be ~7.42 acres**. Annexure 6 presents the cluster wise areas of vegetation as on May 2020.

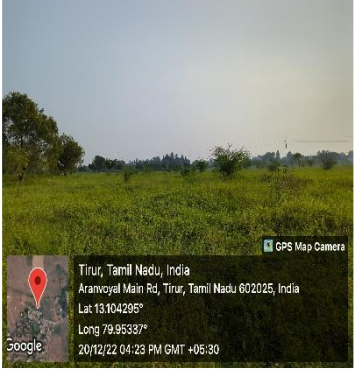
<p>Tree plantation site</p>	<p>UBL branding on rejuvenated lake</p>	<p>Vegetation and sedimentation in lake</p>

Protection of saplings planted: Fencing could have been done around the plantation site to avert the damage due to livestock and help in the long-term conservation of the saplings and the villagers will be able to derive benefits of the same.

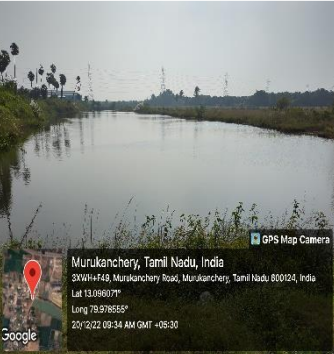
<p>Murukancherry lake</p>	<p>Removal of <i>Prosopis juliflora</i> from site 1</p>	<p><i>Prosopis juliflora</i> in lake</p>

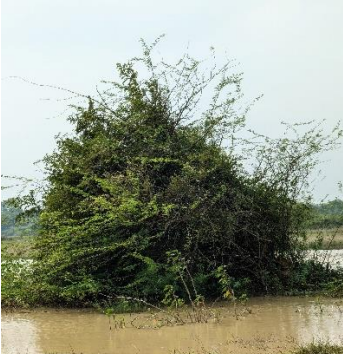
It was observed that currently the involvement of the Gram Panchayat was limited with regards to ensuring the maintenance of the rejuvenated lakes & ponds, removal of *Prosopis juliflora* and trees planted in the villages. In some of the villages, the lakes need maintenance for sedimentation & growth of plants. There has been regrowth of *Prosopis juliflora* & saplings planted have been grazed by the livestock.
